Subject: Final Reclamation at Escalante Mine

**RECLAMATION PLAN
FOR FINAL CLOSURE OF THE
ESCALANTE SILVER MINE
IRON COUNTY, UTAH**

Sheet 1. Final Closure Reclamation, Escalante Mine

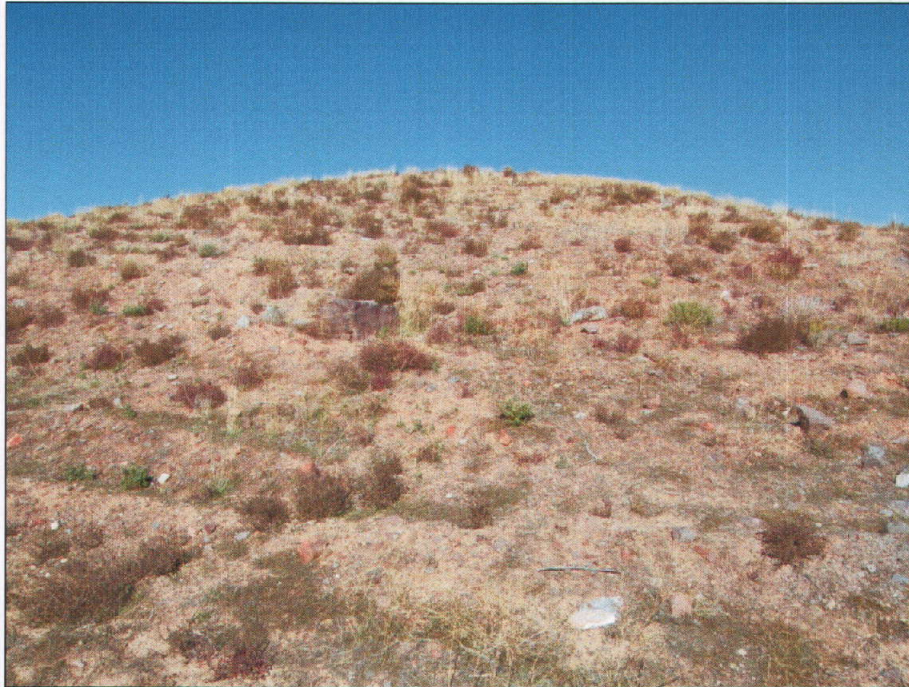
Photo 1. South slope of the Waste Rock Pile, Escalante Site, October 14, 2010.

The Waste Rock Pile had earthwork and seeded done in October 2005, five years prior to this inspection. The surface of the Waste Rock Pile had a total ground cover of approximately 40 to 45%. Of this, approximately 10 to 15% of the cover was grasses and native forbs including a unidentified mint species, beard's tongue (*Penstemon* sp.), and wildrye (*Elymus cinereus*). Approximately 30% of the cover was by invasive species (weedy species) and included cheatgrass (*Bromus tectorum*), Russian thistle (*Salsola kali*), and tansy mustard (*Descurainia pinnata*).

The Waste Rock Pile has revegetated to an acceptable cover of desirable species for this desert region. The weedy species cover is moderately high, but not unusual for a disturbed reclamation site.

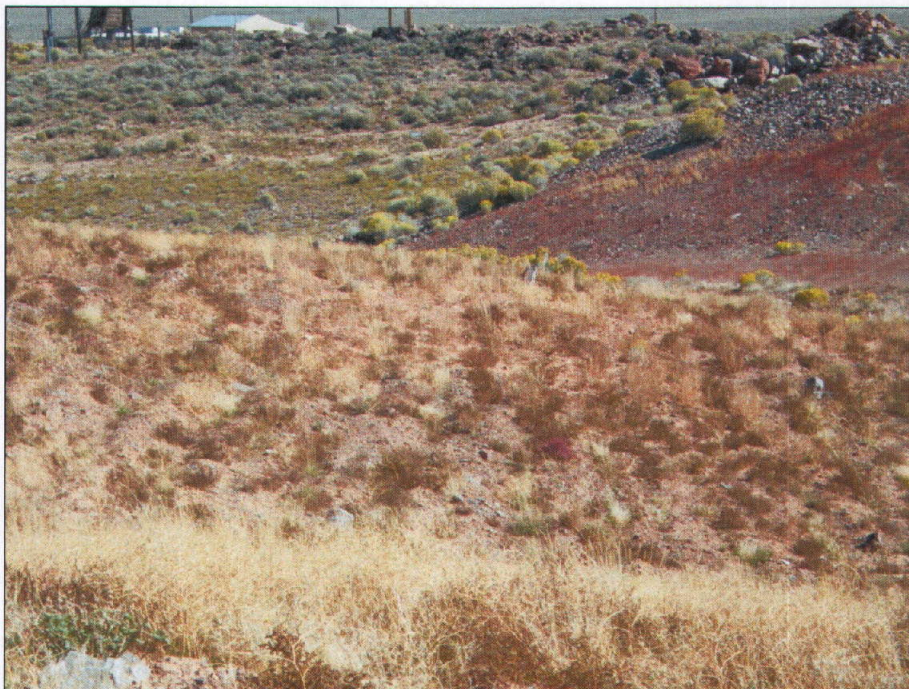
Photo 2. North slope of the Waste Rock Pile in foreground, Escalante Site, October 14, 2010.
